**UNITED TESTING
SERVICES**

CPSC REPORT NO. 20180519-A9E35-2147387862
Recall Number 12-117
UL 147 Compliance Failure Submission
February 14, 2019

Hand-Held Torch Failure and Injury Study

**Related Brands Including: BernzOmatic, Medina,
Worthington, Sears, Ace, and Lenox**

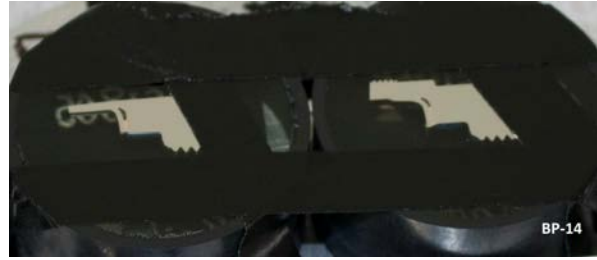
BP-14

test sections were taken from the center valves of Bailey and Peralta cylinders

The impermissible voids noted on the Bailey and Peralta cylinders evidence a compliance failure with [DOT 39](#) and [UL 147](#), and are generally identical to voids noted by an expert witness metallurgist [Dr. Robert Anderson in his study of another injury case in the year 2008](#).

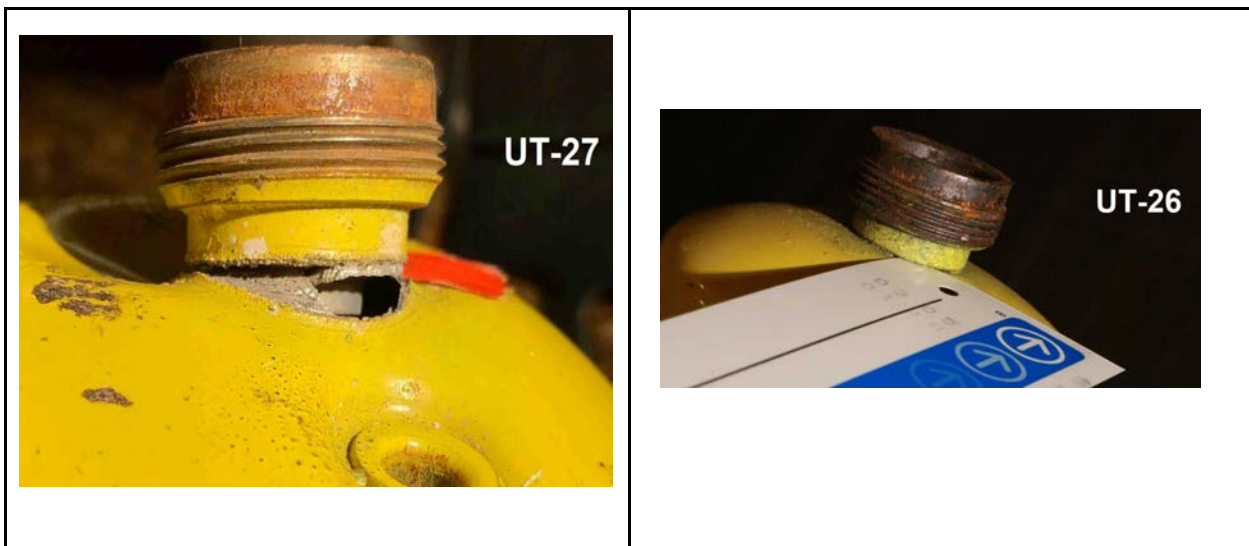
The Bailey and Peralta cylinders also failed to comply with [DOT 39](#) requirements, evidencing manufacturing defects which resulted in failure of the parent steel in the center valve brazed joint area. It is axiomatic in the welding industry that reduced weld surface area will result in increase in stress to the parent metal because the forces are focused only at the point of fusion of the weld or braze to the parent metal. The void shifts stress to the point of contact where the tear in the steel occurs:

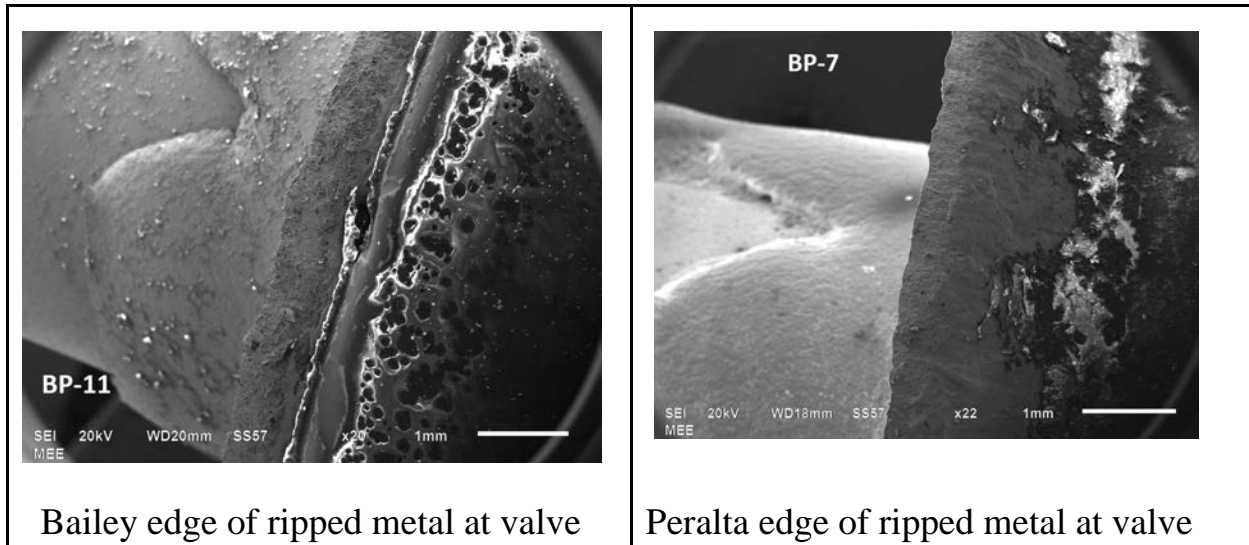
The [SEM](#) images also show that the Bailey cylinder had additional manufacturing defects evidenced by comparison to the Peralta Cylinder [SEM](#) images.

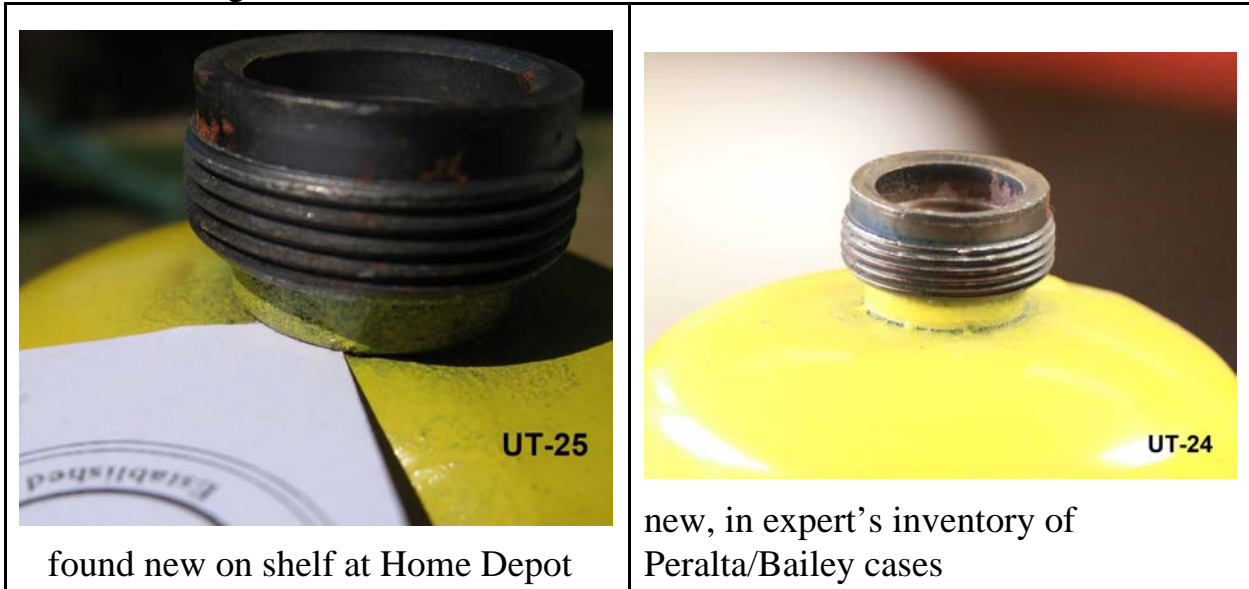
The defects noted above and in the many cases filed with the Courts exist on the NRT cylinders containing both types of fuel, often times with voids visible to the eye without the magnification.

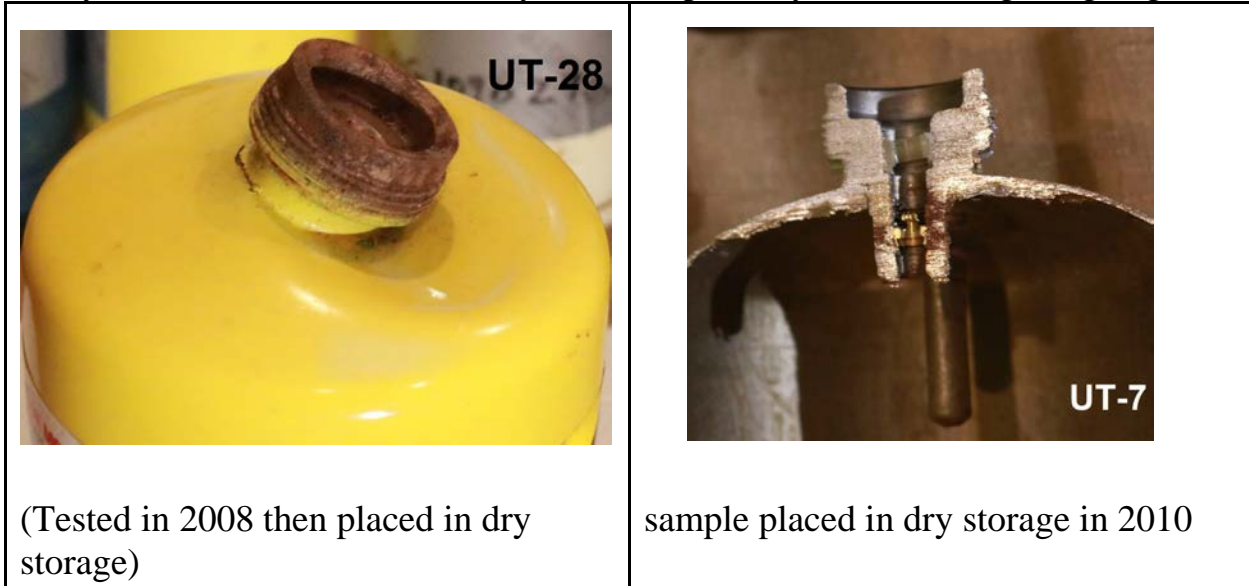
Heavy rust was also observed on cylinders kept in dry indoor storage (a garage).

[UL 147](#) and [DOT 39](#) require reasonably adequate rust and corrosion protection. Quality control is lacking in this area as well.

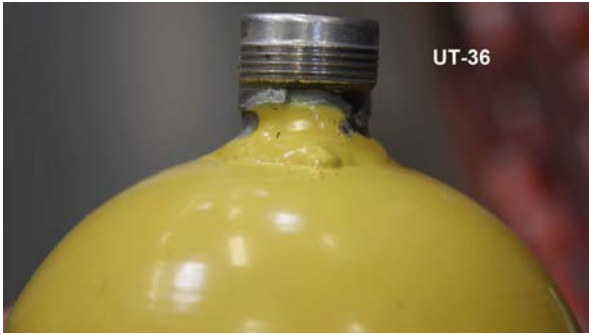
welded cylinder found as photographed on the shelf at Home Depot

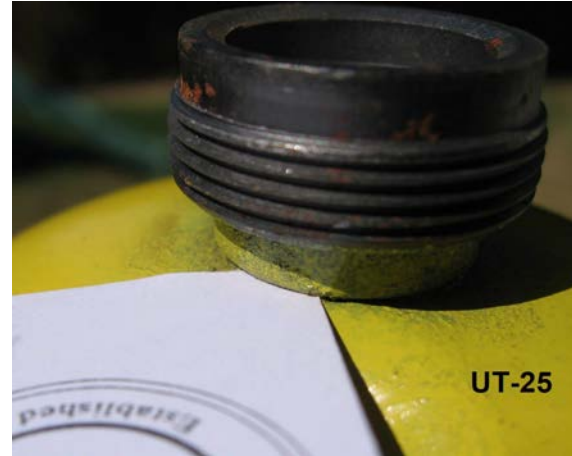
Poorly brazed joint as found on the shelf at Home Depot.
