**UNITED TESTING
SERVICES**

CPSC REPORT NO. 20180519-A9E35-2147387862
Recall Number 12-117
UL 147 Compliance Failure Submission
February 14, 2019

Hand-Held Torch Failure and Injury Study

**Related Brands Including: BernzOmatic, Medina,
Worthington, Sears, Ace, and Lenox**

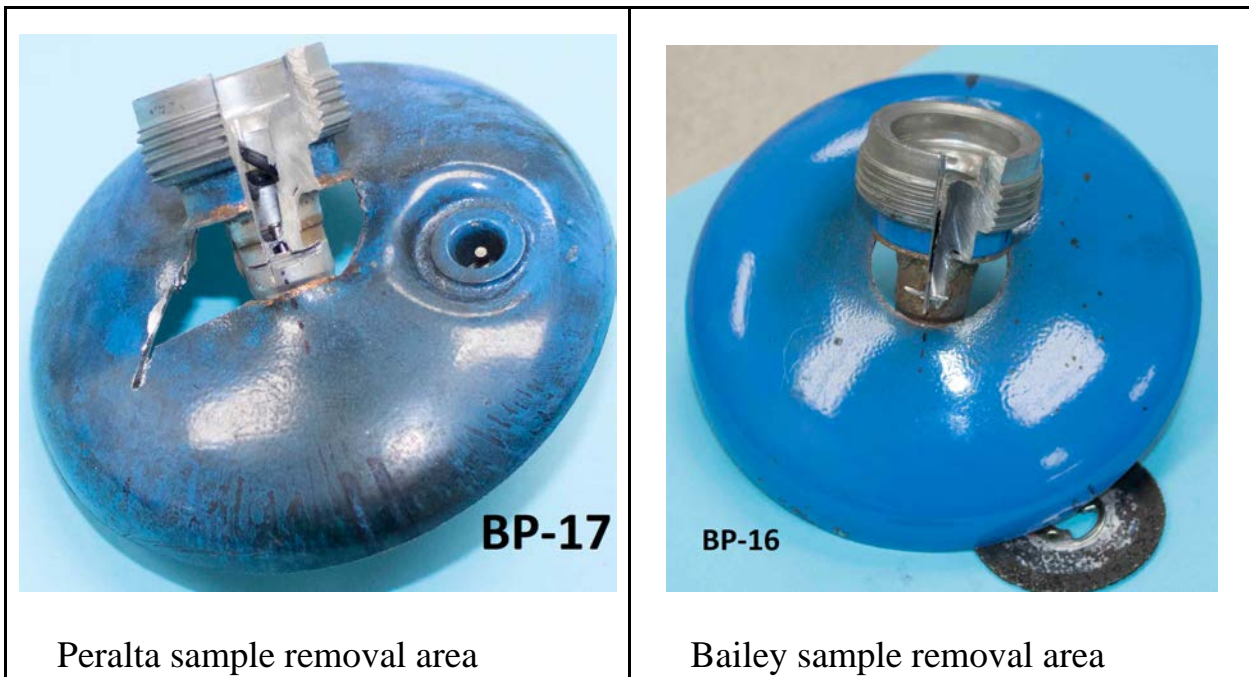
The x-ray samples were taken from the center valve cross-sections of the Bailey and Peralta cylinders.

The impermissible voids noted on the Bailey and Peralta cylinders evidence a compliance failure with [DOT 39](#) and [UL 147](#), and are generally identical to voids noted by an expert witness metallurgist [Dr. Robert Anderson in his study of another injury case in the year 2008](#).

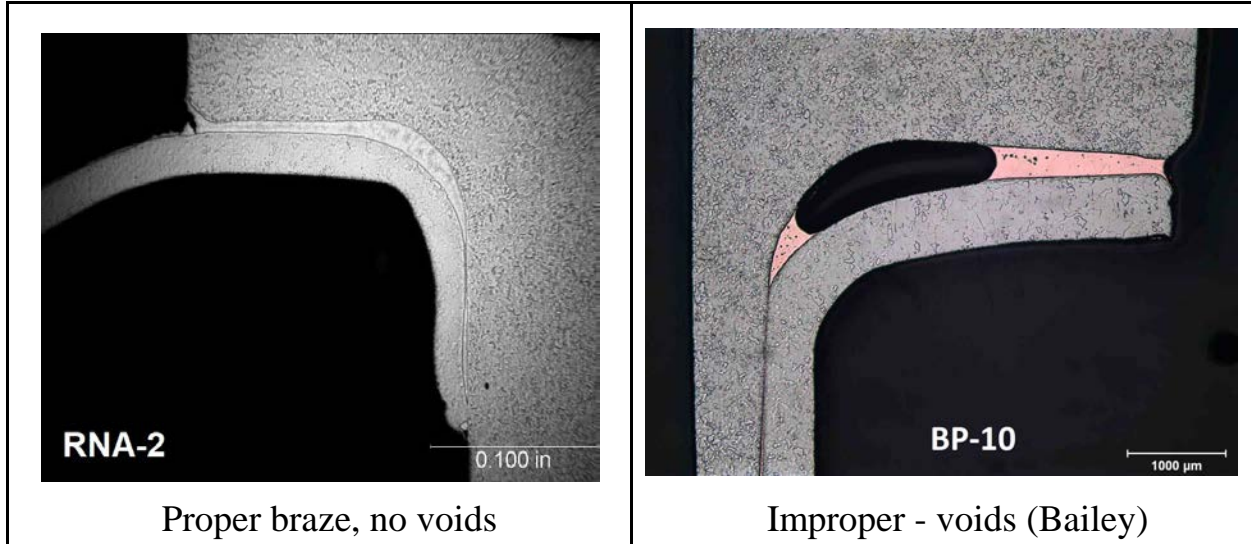
RNA-1

Expert Anderson’s cross-section photo evidence an identical manufacturing defect on another NRT cylinder in relation to [Plaintiff] v. Worthington, et al., 07-cv-2107-MMA.

Dr. Anderson identified the test cylinders as: W10G57E, W11G152W, and W8G230E, and noted that “[T]he brazing materials have large voids in the bulk and smaller voids in the interface between the cylinder walls and the valve housing.”

Dr. Anderson pointed out that the voids are at the brazed bushings near the points of failure, and evidence a compliance failure with the Federal Government’s manufacturing requirements, commonly known as the Dept. of Transportation “DOT 39” requirements, which are found in Title 49, Chapter I, subchapter C, Part 178 of the U.S. Federal Register, cited as [49 CFR 178.65](#). The requirements are found at the following link:

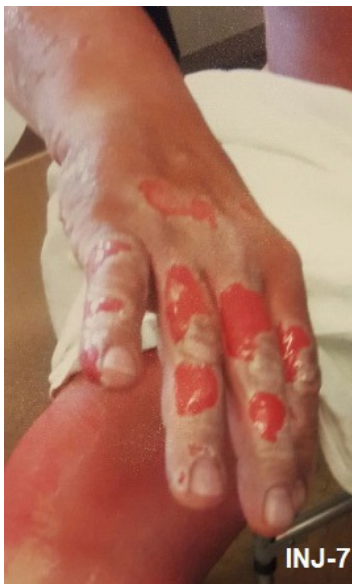
Mr. Bailey

In both instances the product was held at the lower portion of the cylinder, and light force was applied to the fracture groove-equipped torch attachment, insufficient to cause fracture. Nevertheless both cylinders failed identically at the area of known vulnerability, the center valve brazed joint area.

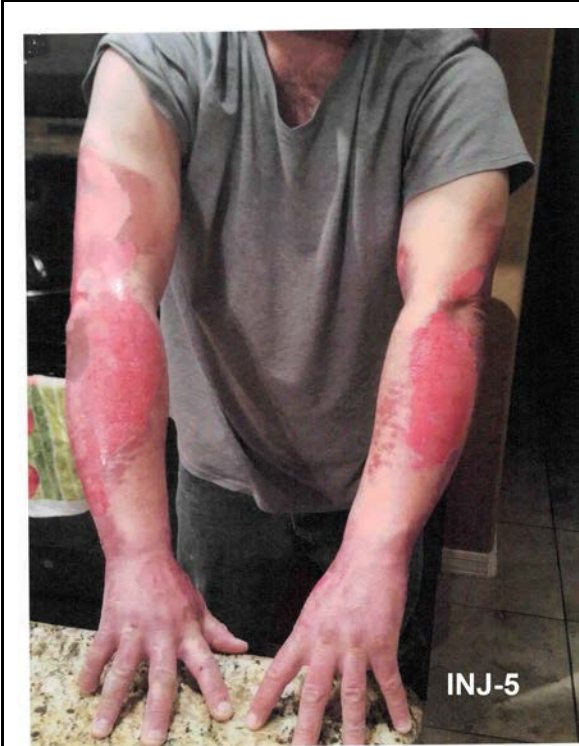
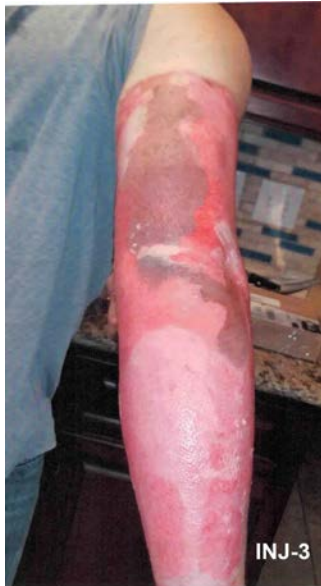
Mr. Peralta

Mr. Peralta's and Mr. Vanderlinde's injuries were nearly identical:
